## Wollombi Brook Flood Study

### Final Report

R.N2390.001.04

Prepared for: Singleton Council

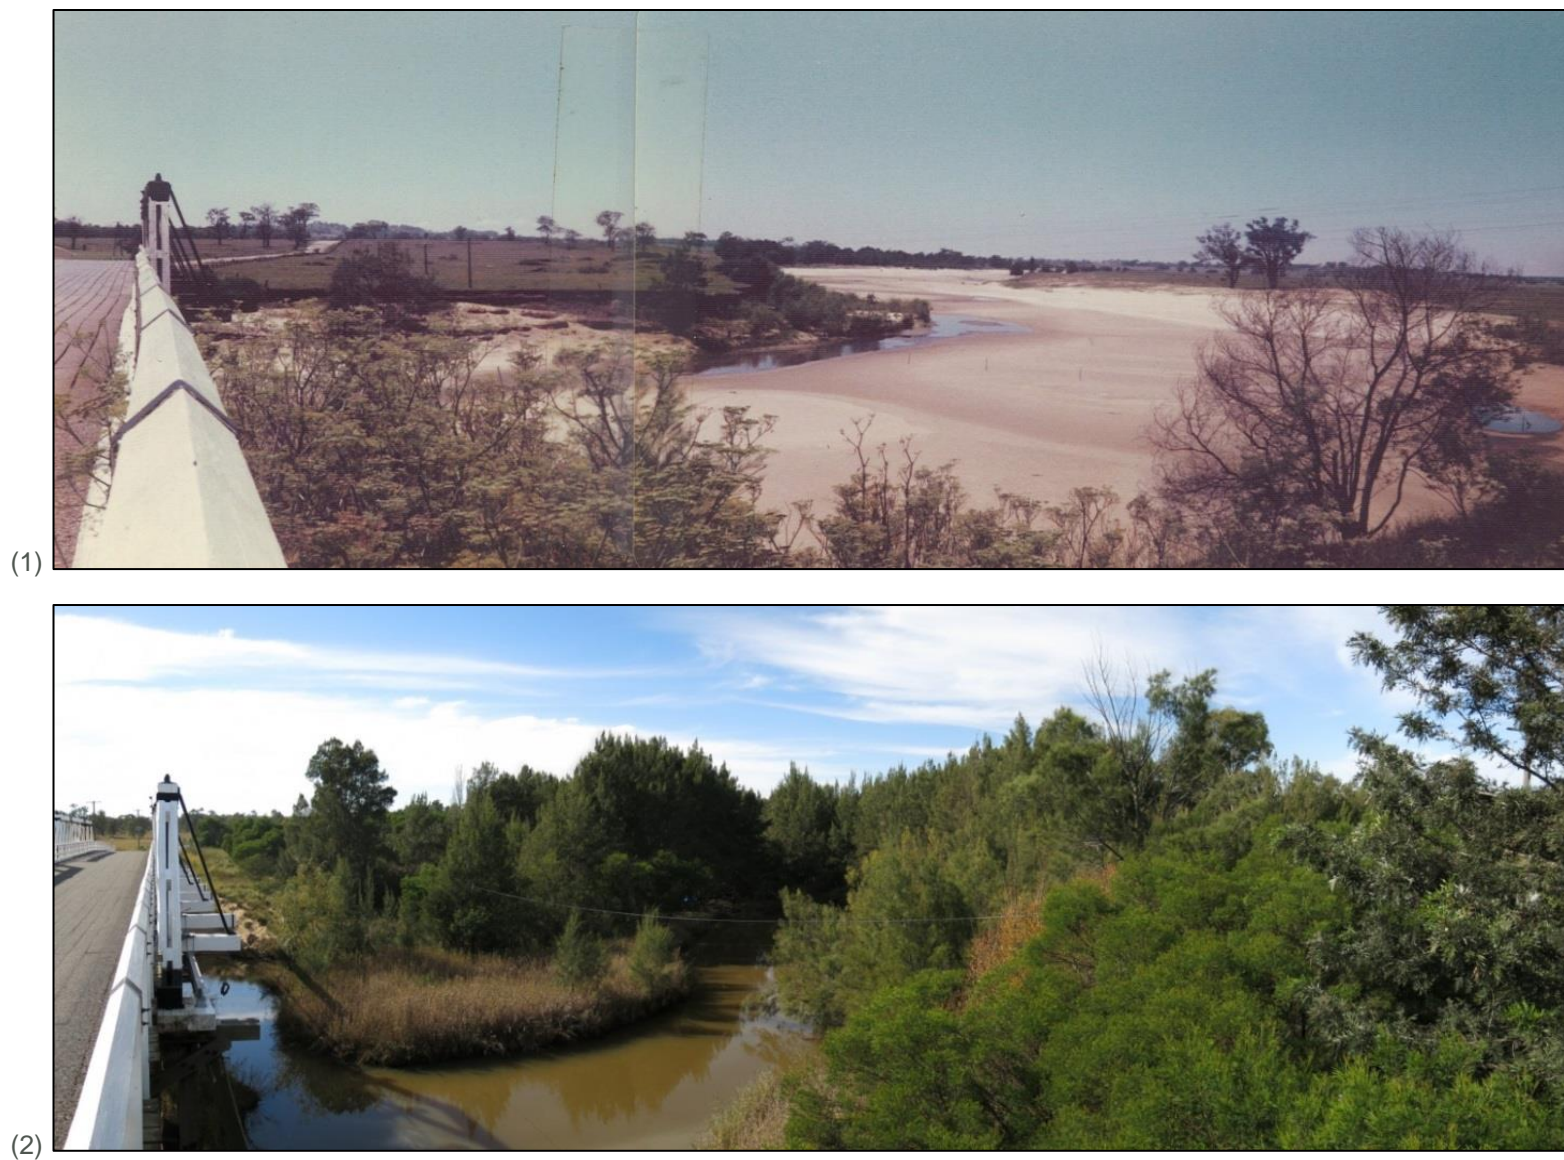
Figure 5-1 Bulga Bridge Looking Upstream (1) 1967 (2) 2014

The increase in in-channel vegetation provides for increased flow resistance, providing for higher water levels for a give flow magnitude. This is clearly evident in the gauge data presented in Figure 5-4, Figure 5-5 and Figure 5-6 for the Bulga, Brickman's Bridge and Warkworth gauges respectively. The figures show the spot gaugings relative to selected historical rating curves as included in the PINENNEA database (rating curve number and period shown for reference). The spot gauging's post June 2007 have been highlighted and clearly follow a different rating curve to the older gauging's. For example, at the Bulga gauge the recorded maximum water level for the June 2007 event (64.07m AHD) equates to a streamflow of ~1,300m<sup>3</sup>/s using the derived rating #10, ~875m<sup>3</sup>/s using the derived rating #280 and 600m<sup>3</sup>/s using the current rating (derived rating #285). This equates to a difference of 700m<sup>3</sup>/s, with the derived streamflow using the derived rating #10 being more than double the derived streamflow using the current rating (derived rating #285). A similar shift is evident at both the Brickman's Bridge and Warkworth gauges.

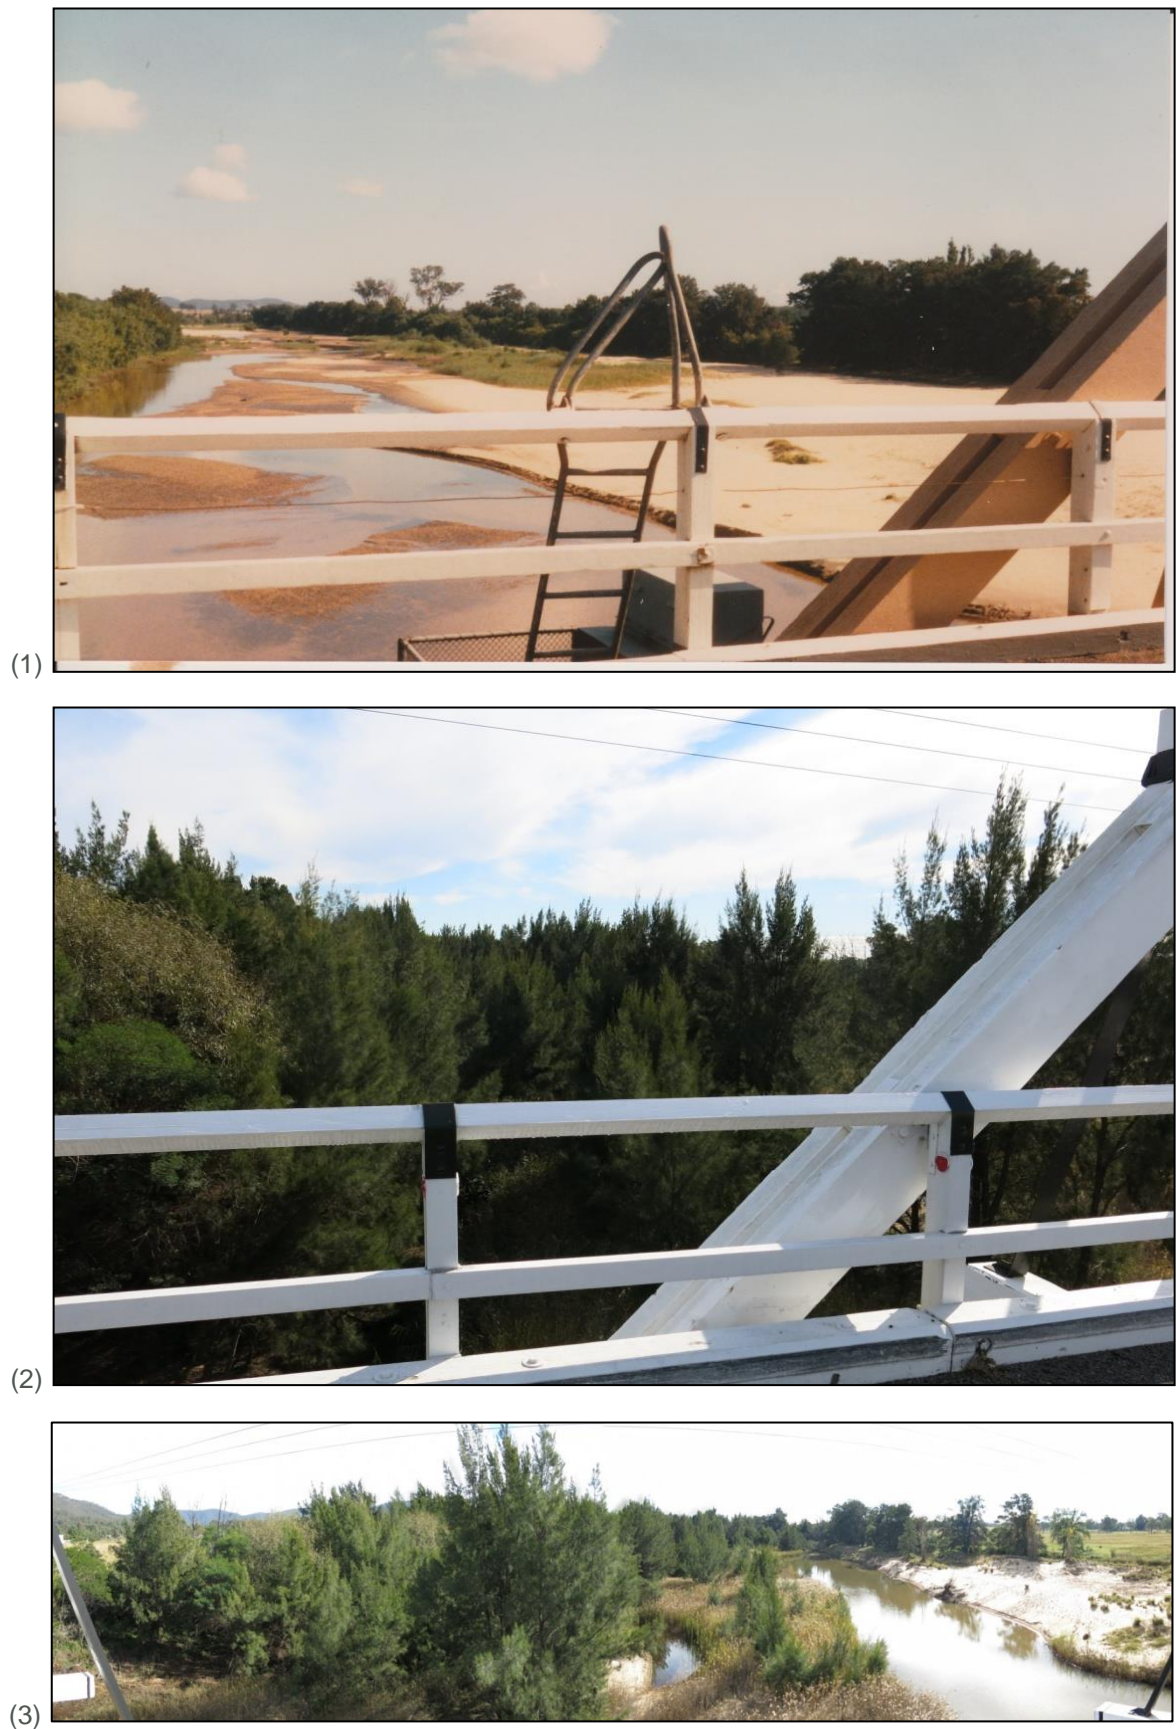
Figure 5-2 Bulga Bridge Looking Downstream (1) 1984 (2) 2014 (3) 2014

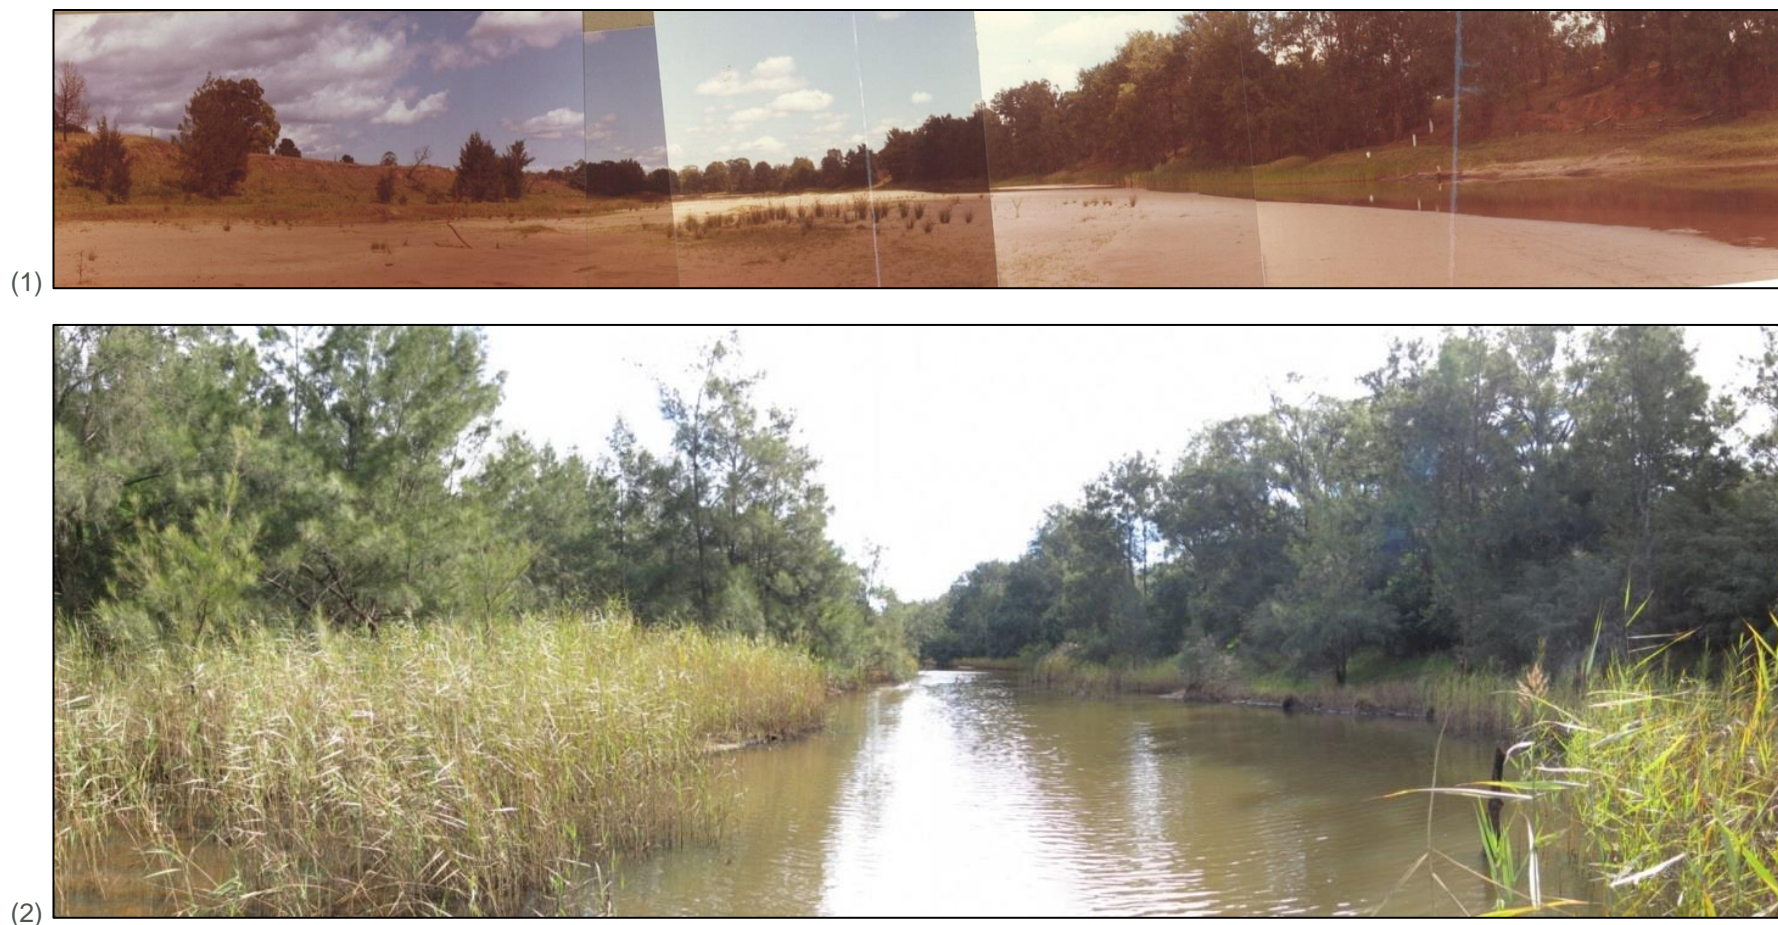
Figure 5-3 Warkworth Gauge Looking Upstream (1) 1983 (2) 2014

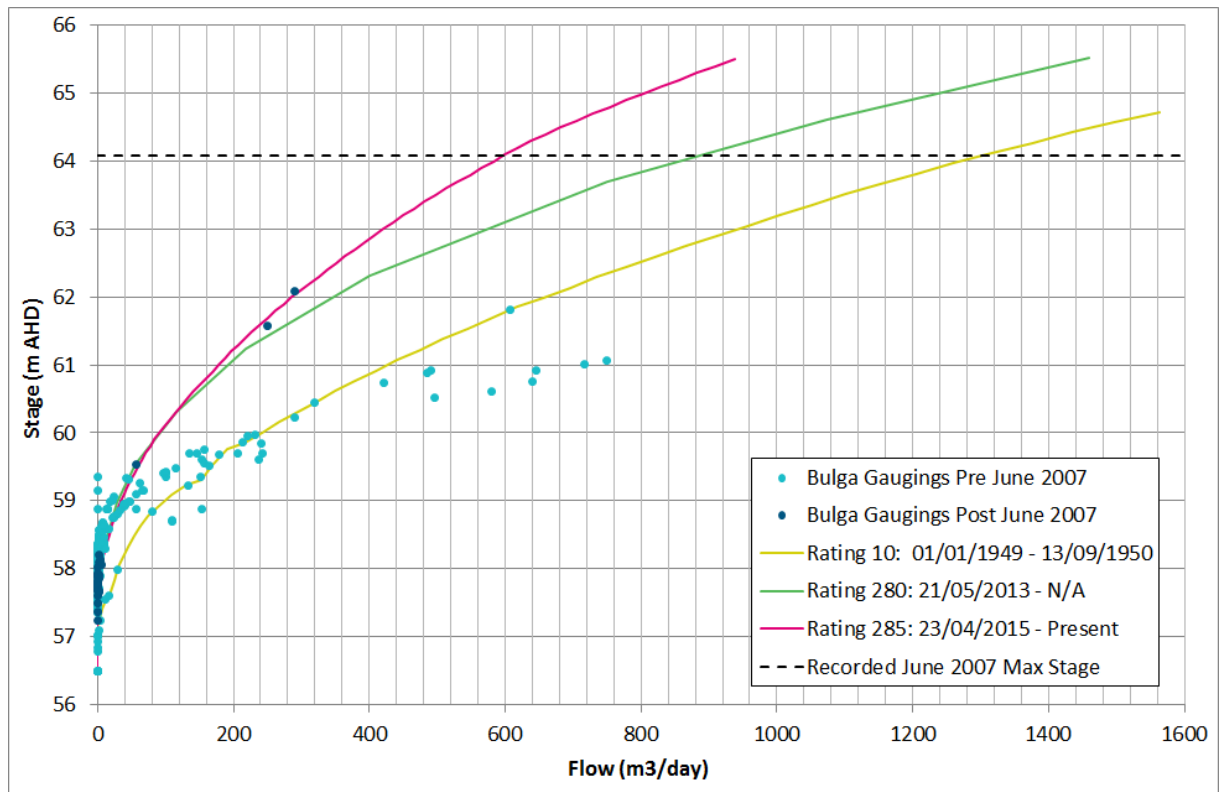
Figure 5-4 Bulga Gauge (210028) Analysis

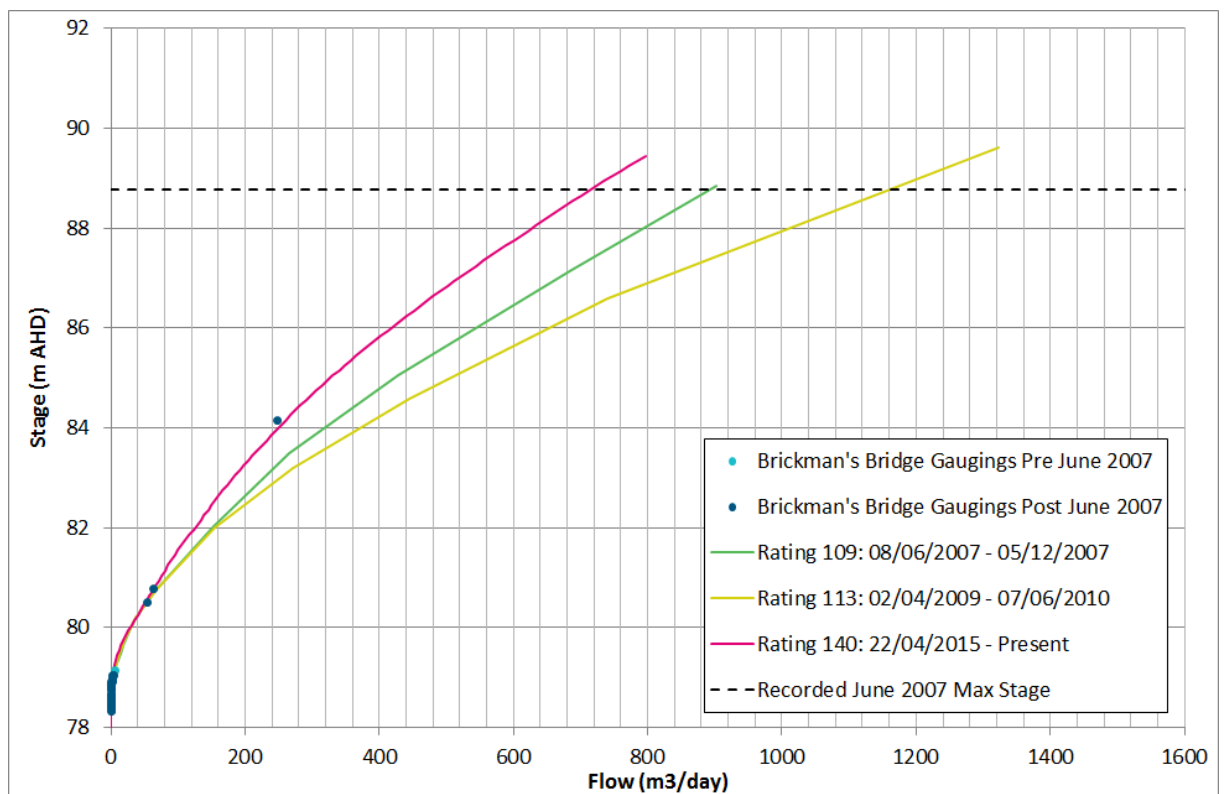
Figure 5-5 Brickman's Bridge Gauge (210135) Analysis

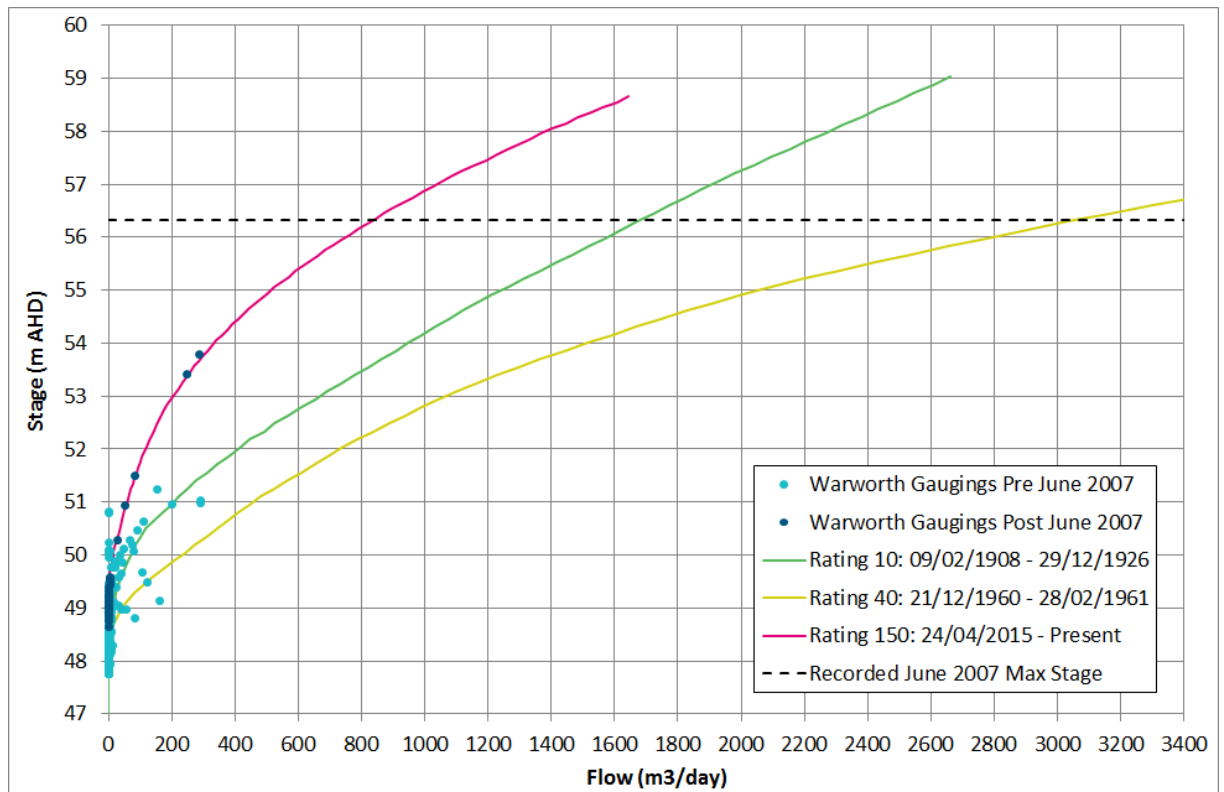
**Figure 5-6 Warkworth Gauge (210004) Analysis**

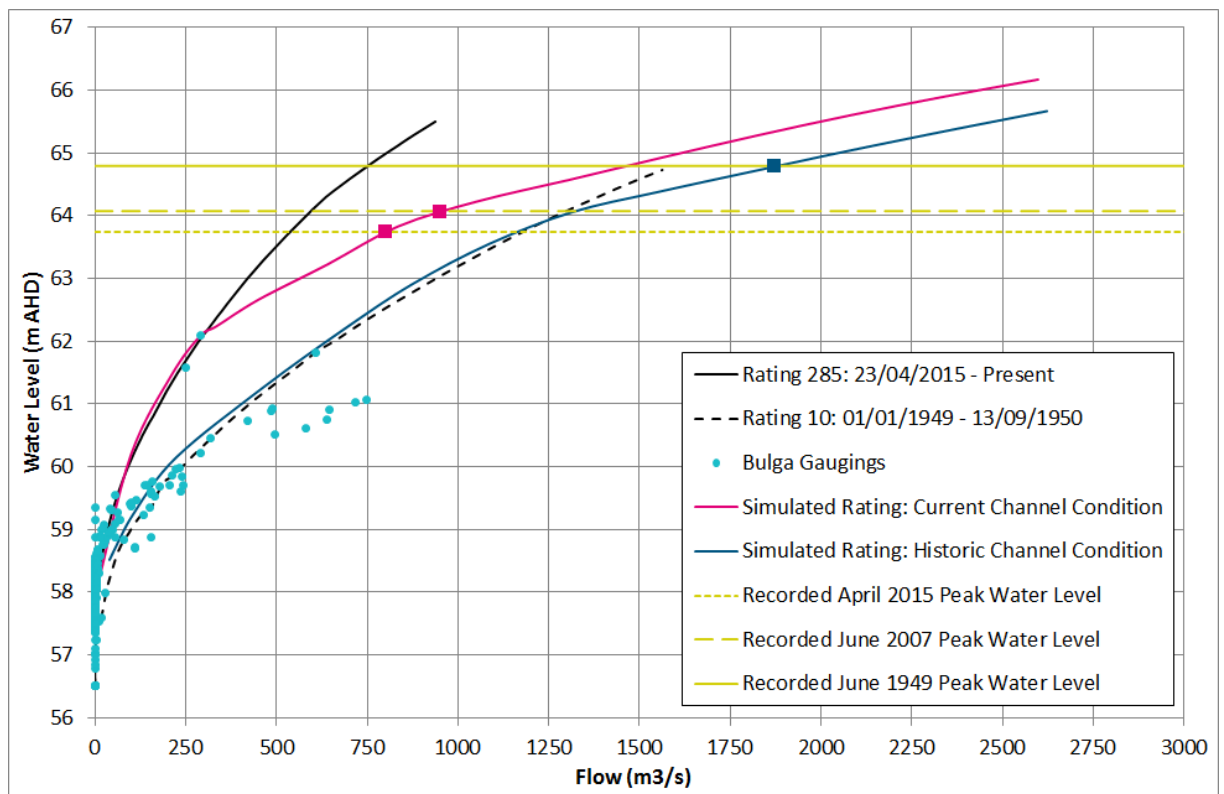
Figure 7-2 Rating Curve Analysis for the Wollombi Brook at Bulga

- the simulated current and historic rating curves according to the adopted roughness distributions,
- a selection of the previously derived rating curves from the PINEENA database;
- the available spot gaugings from the PINEENA database;
- the recorded peak water levels for the April 2015, June 2007 and June 1949 flood events; and
- points showing the recorded peak flood level for the calibration events and the corresponding peak flow estimate based on the appropriate rating curve (see discussion below).

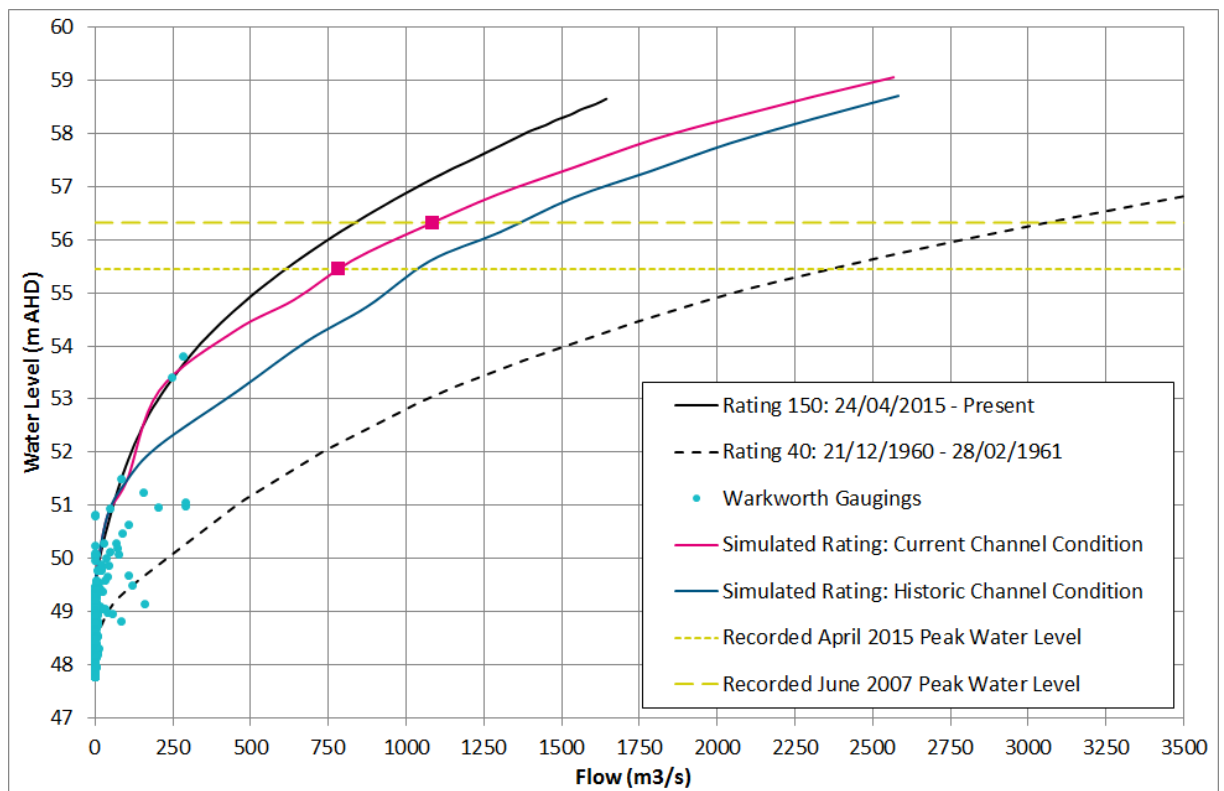
Figure 7-3 Rating Curve Analysis for the Wollombi Brook at Warkworth

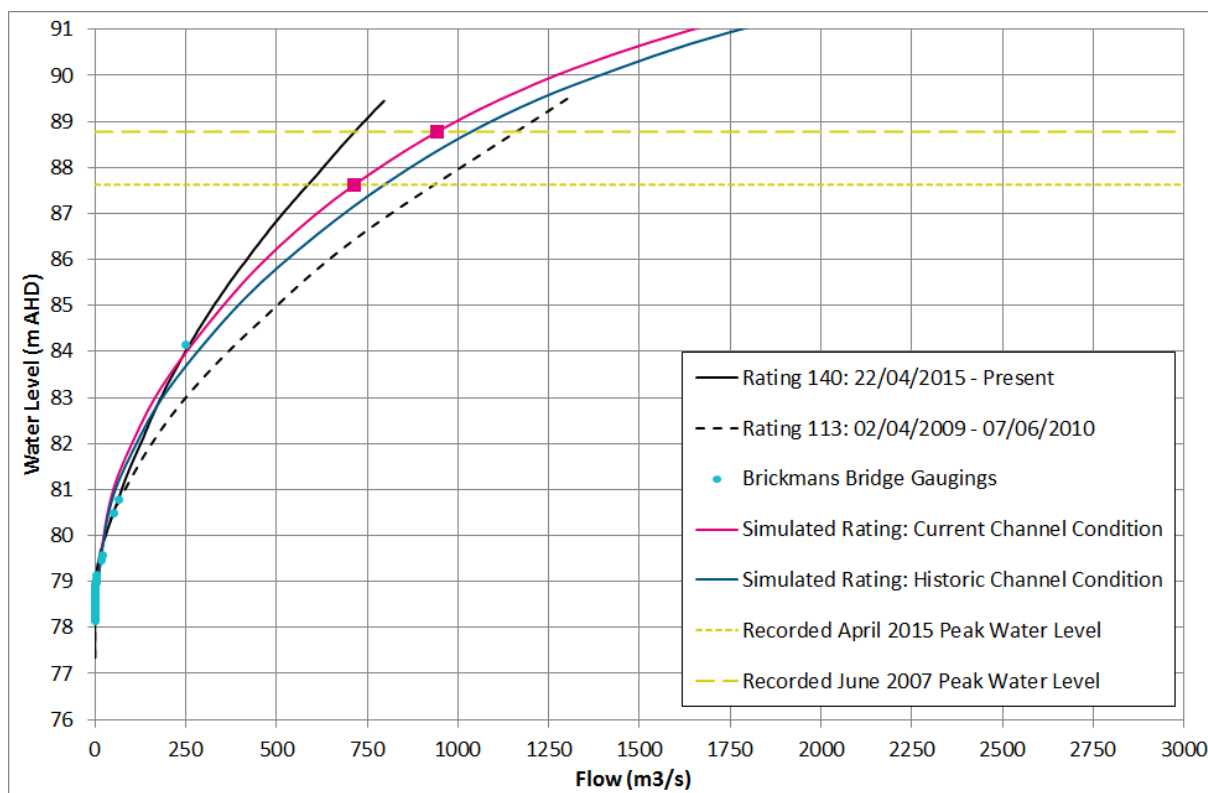
**Figure 7-4 Rating Curve Analysis for the Wollombi Brook at D/S Brickmans Bridge**

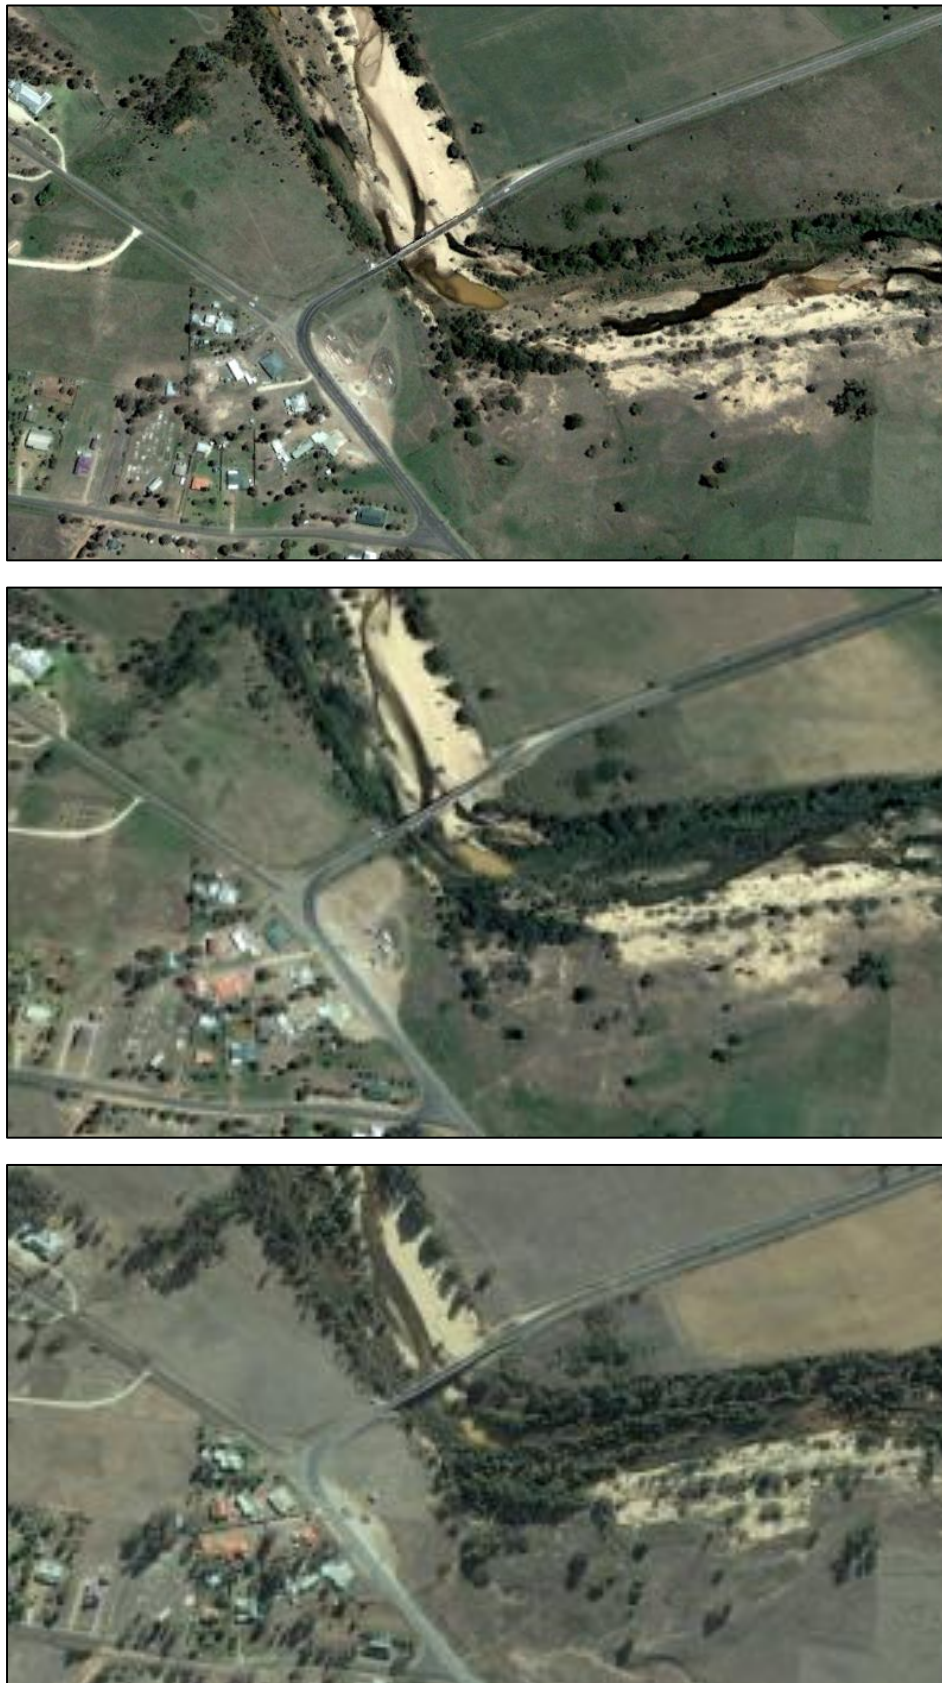
**Figure 7-5 Wollombi Brook Riparian Vegetation Growth at Bulga (Google Earth Imagery)**

To further demonstrate the dynamic nature of the channel vegetation and inherent uncertainty in defining appropriate channel roughness conditions for the calibration events, Figure 7-5 shows aerial photography of the channel reach at the Bulga gauge between 2002 and 2006. As evidenced in the photography, this period was characterised by gradual increase in riparian vegetation in the channel at Bulga. The photographs included in Figure 5-1 and Figure 5-2 around 2014 show a further increase in the local channel vegetation at Bulga to what now may be representative of the current condition.

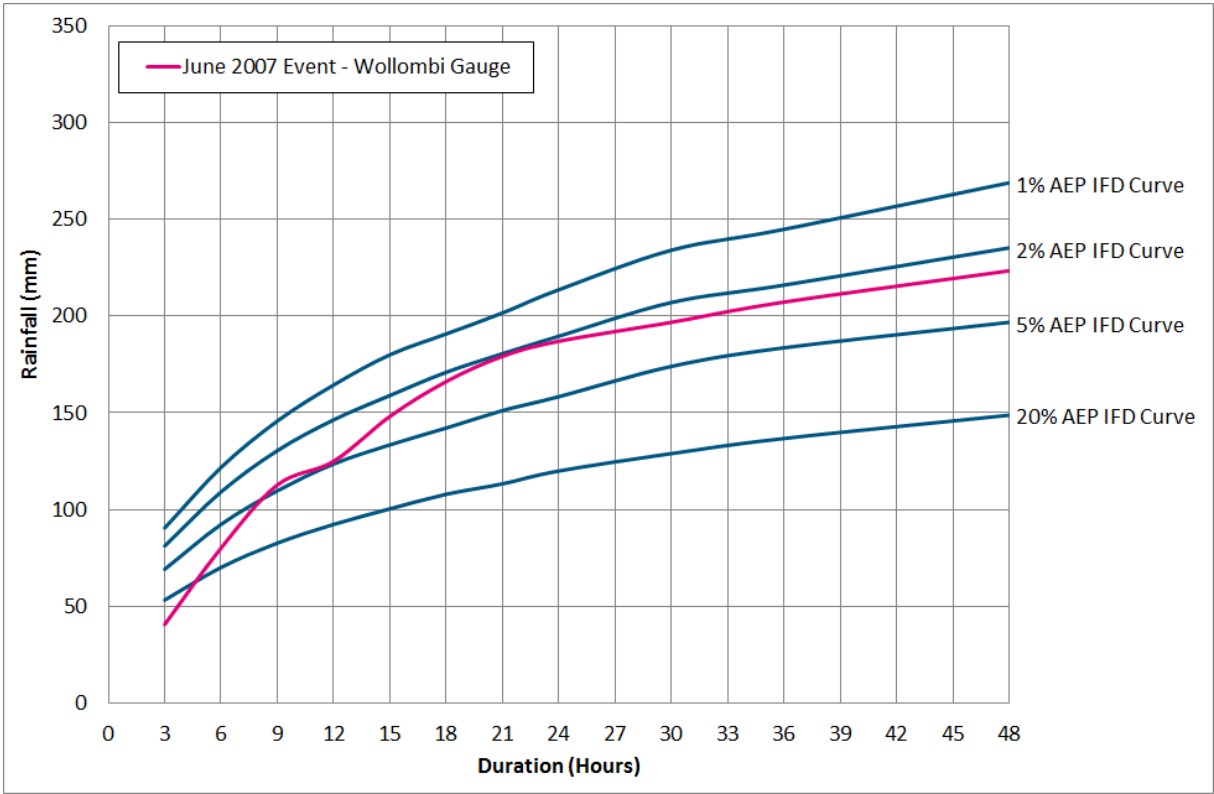
Figure 7-9 Comparison of Recorded Rainfall with IFD Relationships – Wollombi (St Johns Church) Gauge

It is interesting also to note the variation in design rainfall depth between the Wollombi and Watagan Central gauge locations. This is typical of the spatial variation in design rainfall parameters across the catchment. The Wollombi and Watagan gauges are separated by a distance of some 11km, however the proximity of the Watagan Central gauge to the Watagan Mountains range results in higher design rainfall depths when utilising the standard IFD procedures of AR&R (2001).

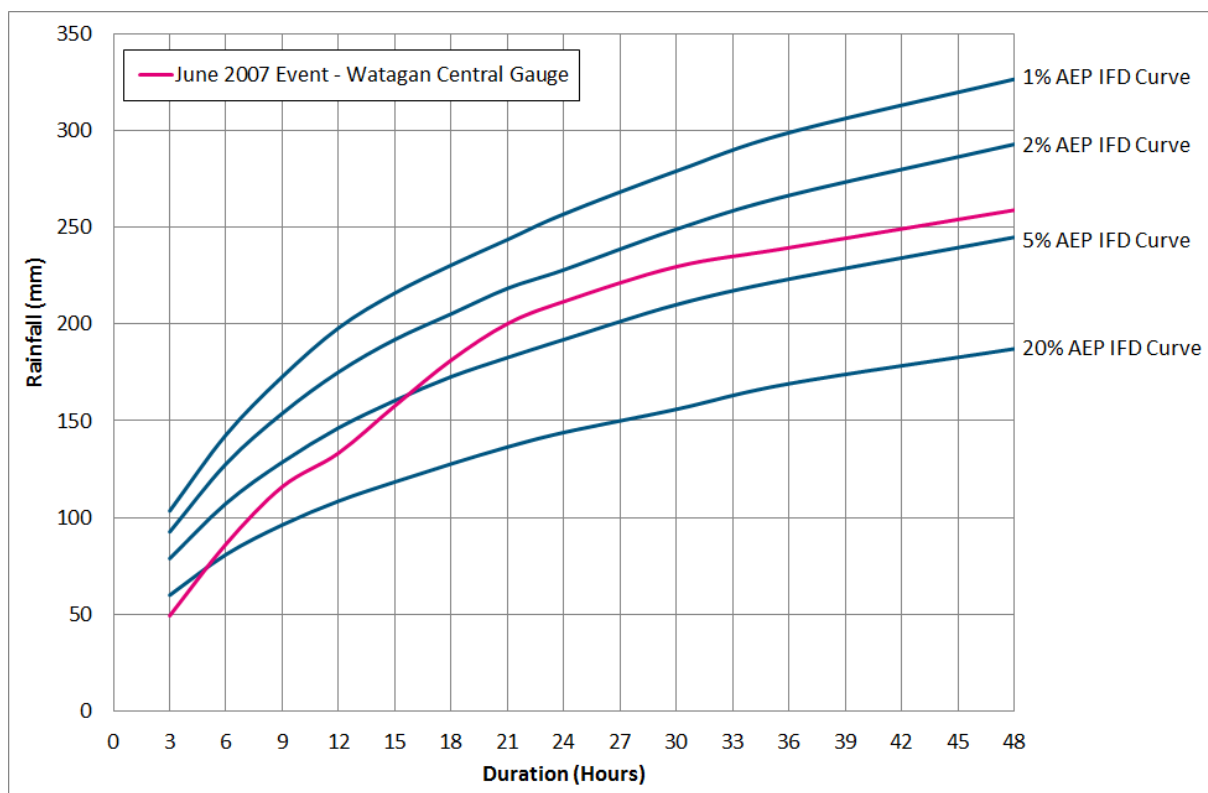
**Figure 7-10 Comparison of Recorded Rainfall with IFD Relationships – Watagan Central Gauge**

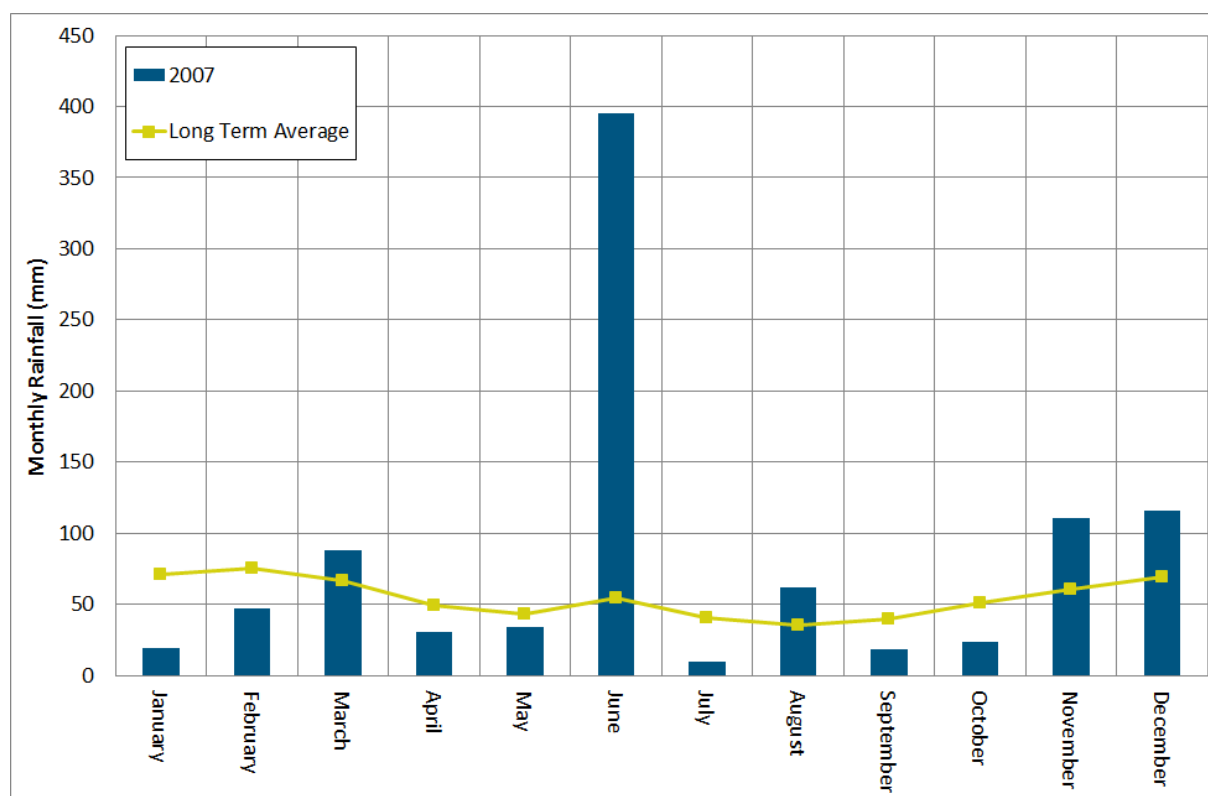
Figure 7-11 Broke (Harrowby) Monthly Rainfall Preceding June 2007 Event

The main rainfall burst that occurred over June 8<sup>th</sup> and 9<sup>th</sup> 2007 was preceded by approximately 10-20mm of rainfall across the catchment on June 7<sup>th</sup>. In considering the catchment wetness condition at the start of the June 2007 event, an initial loss value of 10mm was adopted. Given the duration of the event and the large rainfall depths, the initial loss parameter does not have a major influence on the simulated flow conditions.

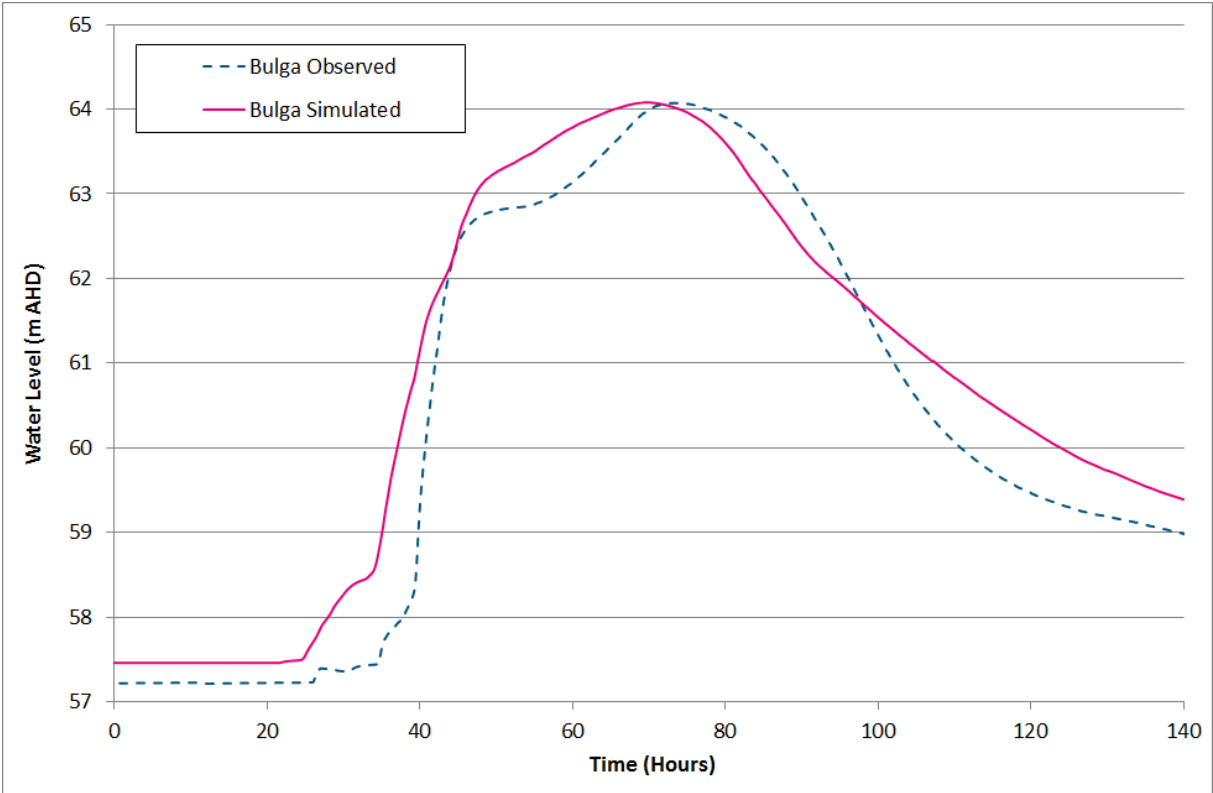
Figure 7-12 June 2007 Observed and Simulated Hydrograph at Bulga

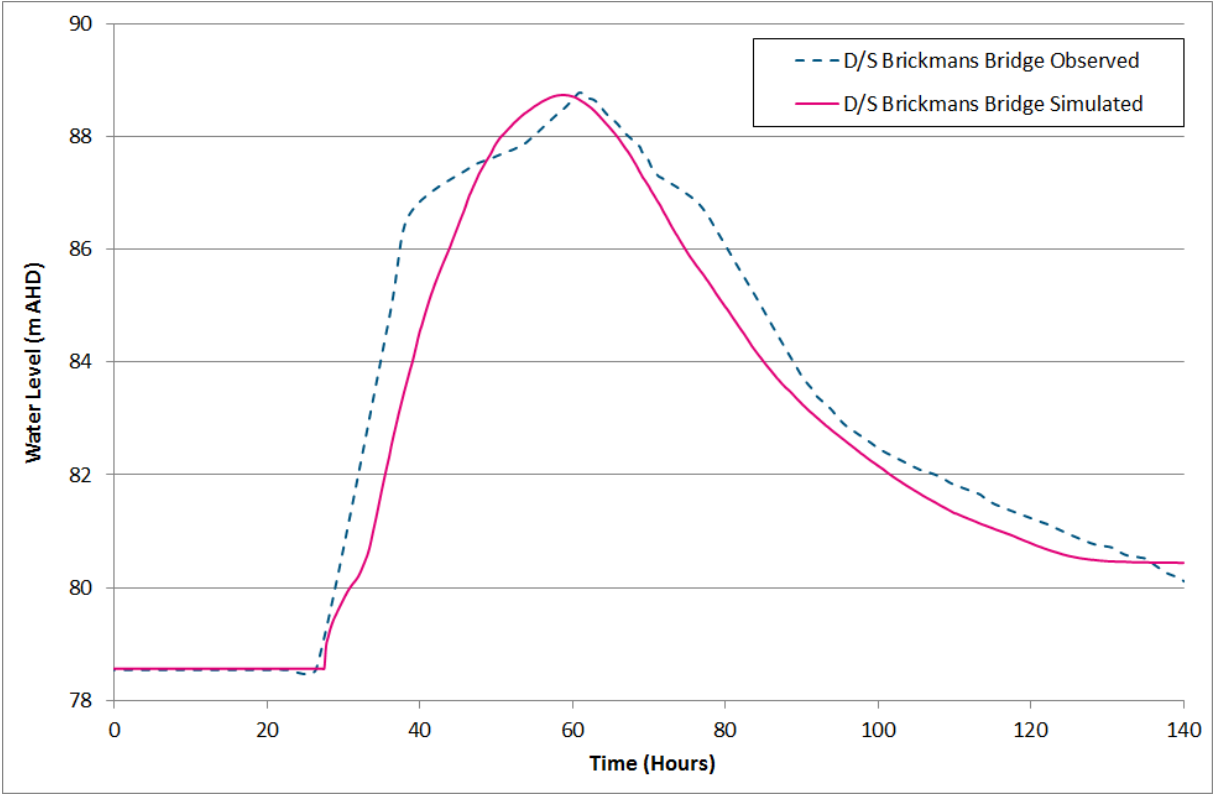
Figure 7-13 June 2007 Observed and Simulated Hydrograph at D/S Brickman's Bridge

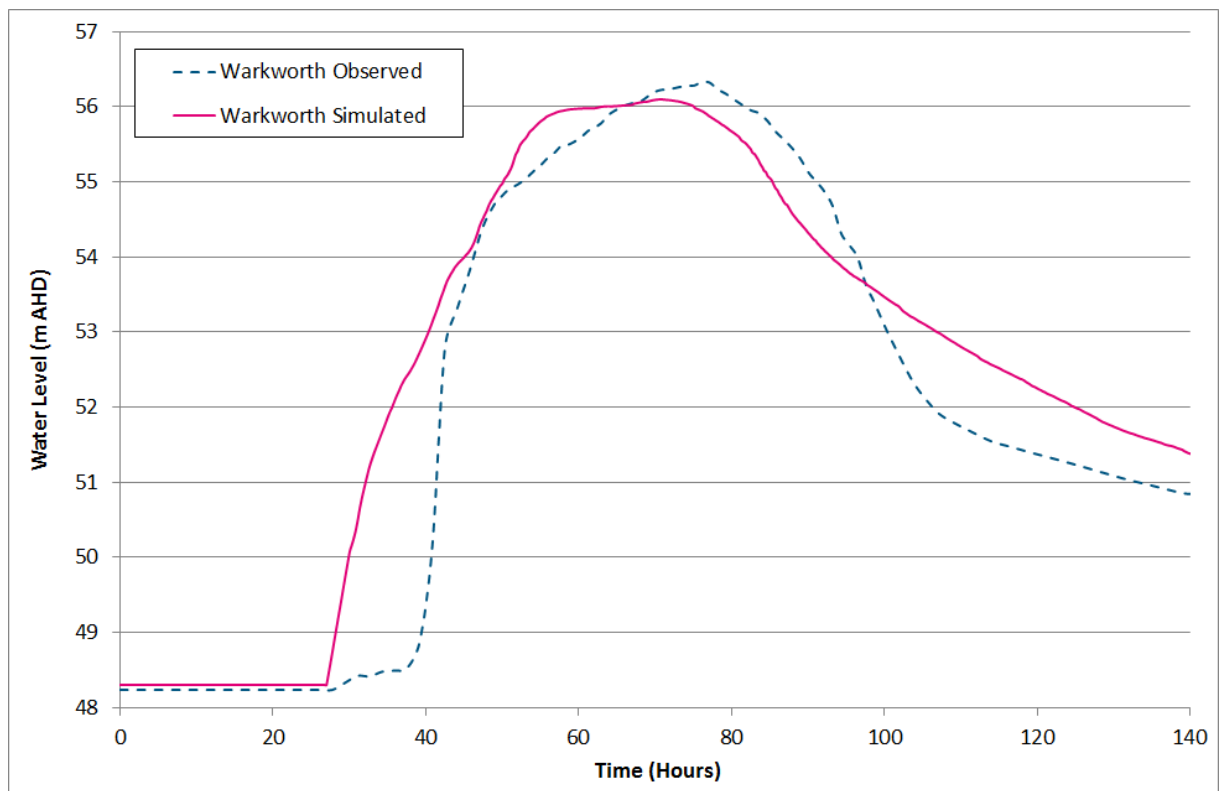
**Figure 7-14 June 2007 Observed and Simulated Hydrograph at Warkworth**

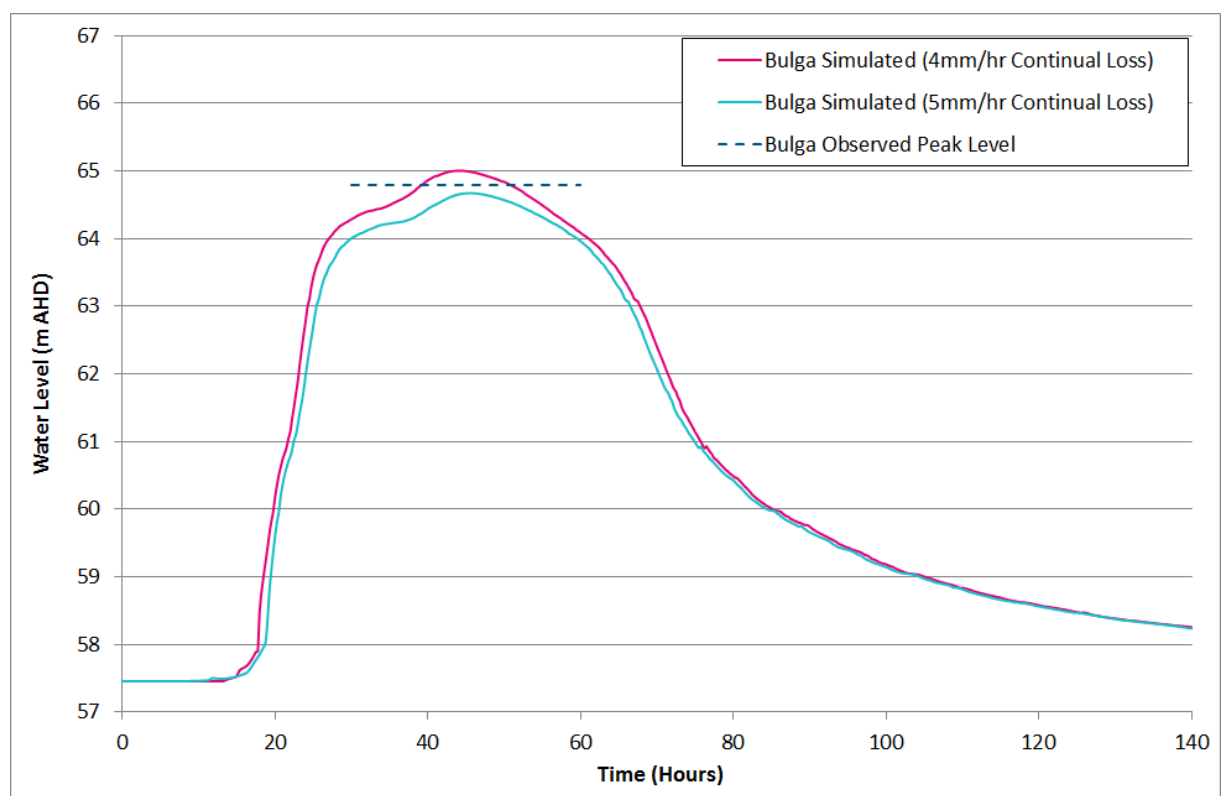
**Figure 7-19 June 1949 Estimated and Simulated Water Levels at Bulga Gauge**
