Wollombi Brook Rehabilitation Project

Newsletter # 3

HUNTER LOCAL LAND SERVICES

July 2021

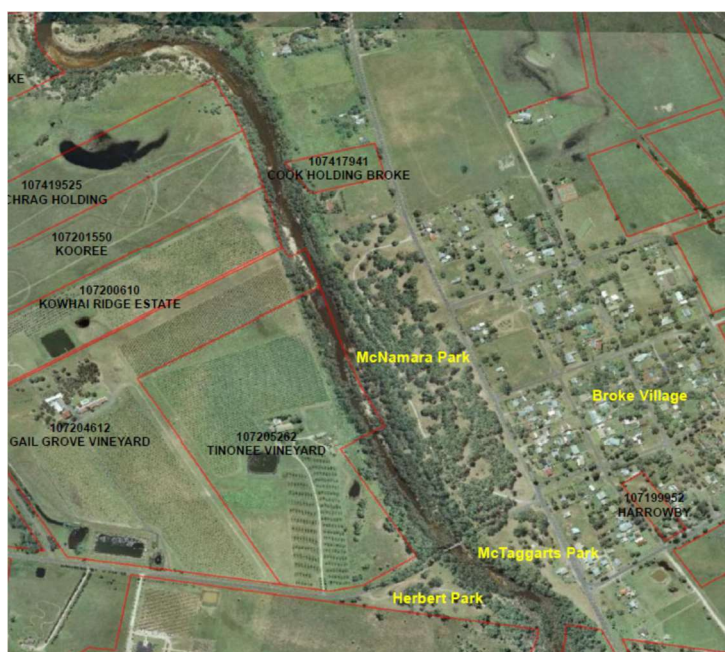
Figure 1: Wollombi Brook Project Area

The project area extends downstream from the Milbrodale Road Bridge to just beyond the first northerly bend of the Brook.

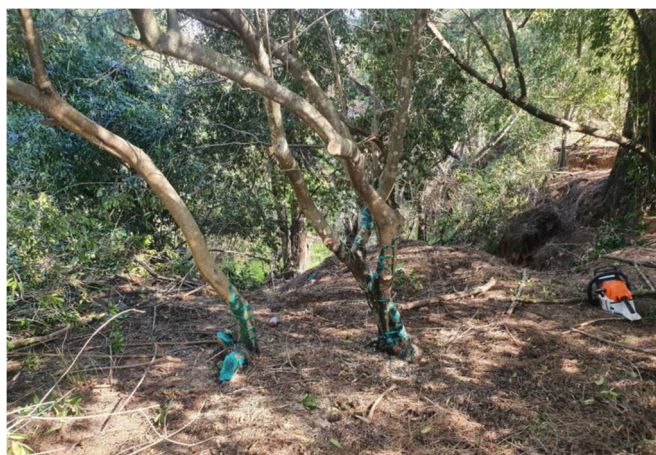
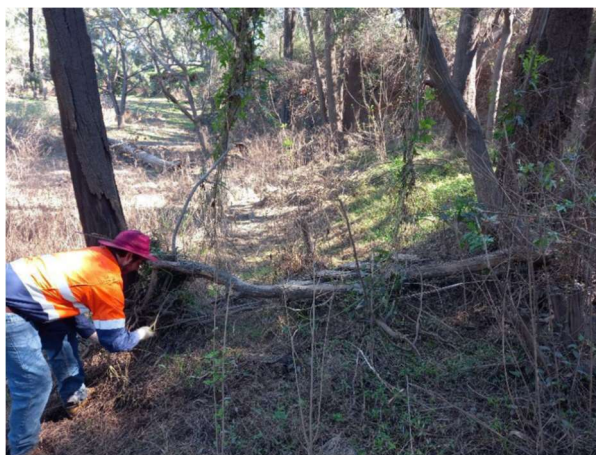
Work on the east bank – African Olive treated using frill-and-fill method (left); hand removing exotic vines (right)

Six sites downstream from the Milbrodale Road Bridge on the west bank of the Brook have now undergone initial plus follow-up weed control work with a seventh property site receiving initial control work. Another six sites on the east bank have also had initial and follow-up weed control work completed. The result has been a significant change to the riparian understorey along the reach which was previously thickly infested with African Olive. This change has shown that native species are now notably re-appearing such as Tea Trees and Green Wattles. Also, of note has been some areas where native grasses and other native groundcovers have re-emerged.

A wide range of other weeds have been treated along the reach such as Moth Vine, Bridal Creeper, African Boxthorn, Tree of Heaven, Tree Pear, Green Cestrum and Cassia.

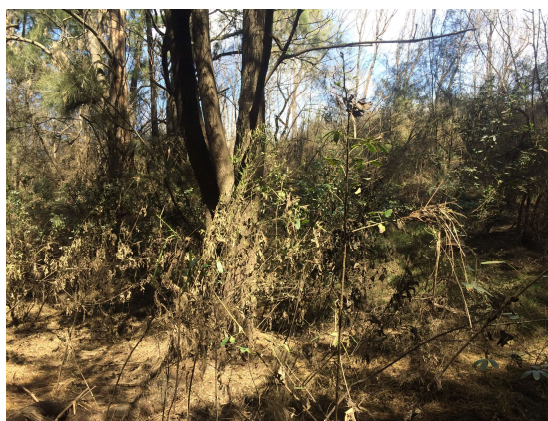
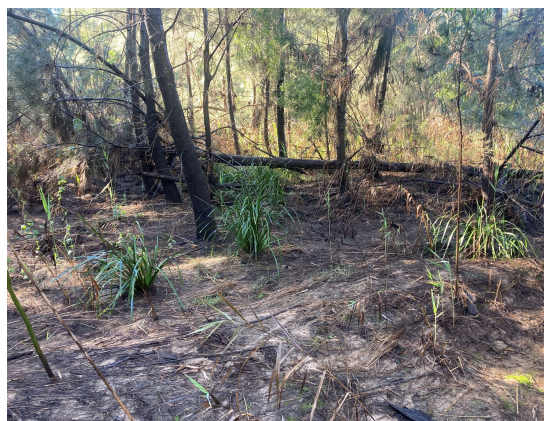
Cassia suffered from inundation along the Brook (left); well established Lomandras near Nightingales (right)

Some weeds such as Tree of Heaven and Cassia were negatively affected by inundation. Plantings of some native shrub species were lost, however while there had been some losses of Lomandra many of them have survived. This was particularly the case along the Brook section of Nightingales Vineyard where it was noticed that planted Lomandra had become more well established amongst stands of Casuarinas.

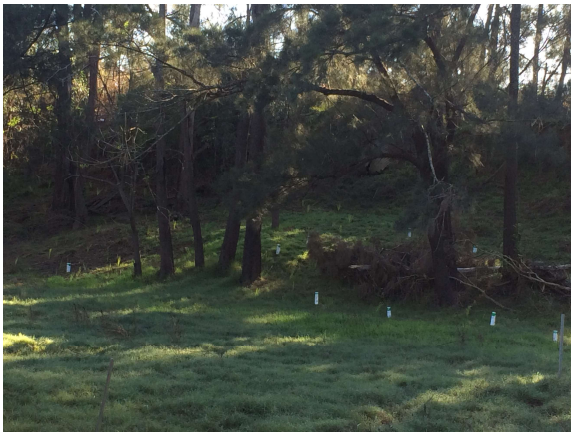
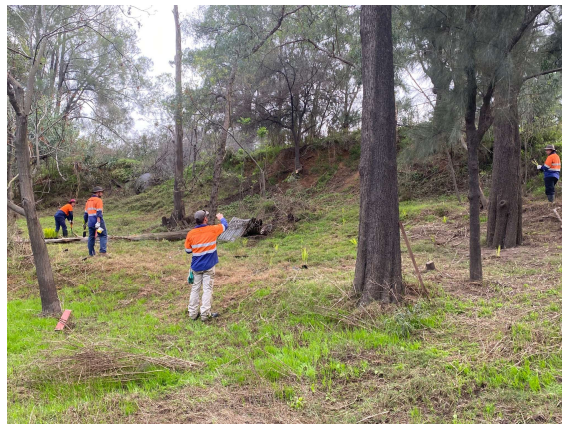
East bank: Plantings of native shrubs to in-fill areas around Casuarinas (left); contractor Toolijooa Environmental Restoration undertaking plantings after site preparation (right).

Plantings undertaken this year have focused on the east bank with a further batch of plantings scheduled for the west bank in late winter/early spring.

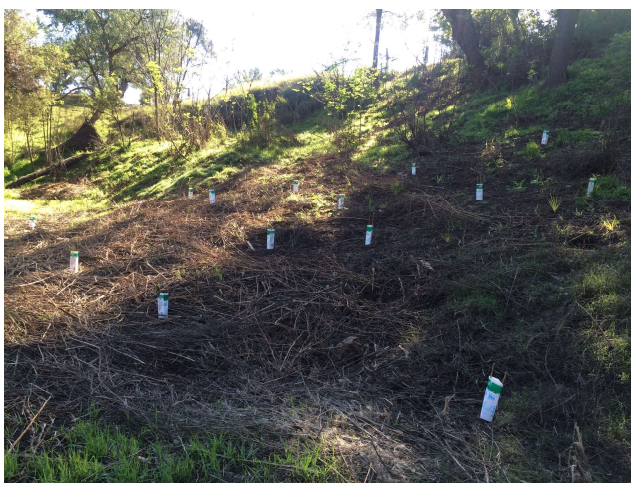
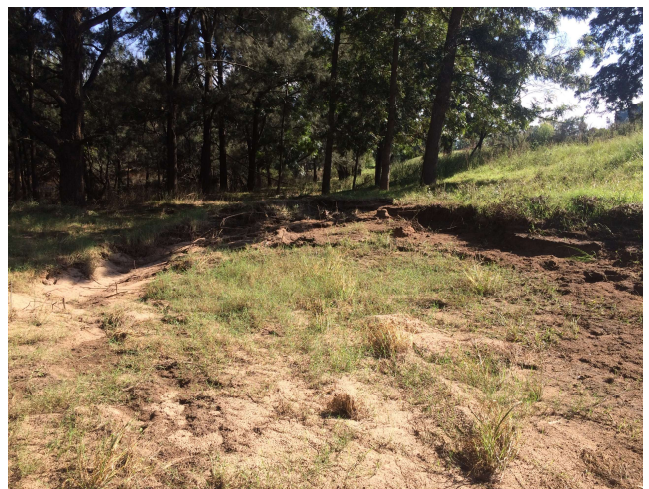
*Mixed plantings of trees, shrubs and *Lomandra* on back bank tier on the east bank (left); example of loss of sediment from flood inundation on the east bank, area since planted out with *Lomandra* sedges and shrubs (right).*

Some minor erosion and movement of sand was noticed along the reach of the Brook resulting from the flood inundation in March which appeared to be a slow-moving flood event. Planting *Lomandra* aims to prevent this from happening and they tolerate inundation well once established. Grasses alone on banks do not have the deep root system required compared to *Lomandra* and native shrubs to help hold sandy sediment together.
